Re: Compliance Evaluation Inspection of the Central District Wastewater Treatment Plant
Notice of Violation
National Pollutant Discharge Elimination System Permit No. FL0024805

COMPLIANCE EVALUATION INSPECTION REPORT

**Miami-Dade County, Florida
Water and Sewer Department
Central District (Virginia Key) Wastewater Treatment Plant
Miami, Florida
NPDES Permit No. FL0024805**

May 1-2, 2014

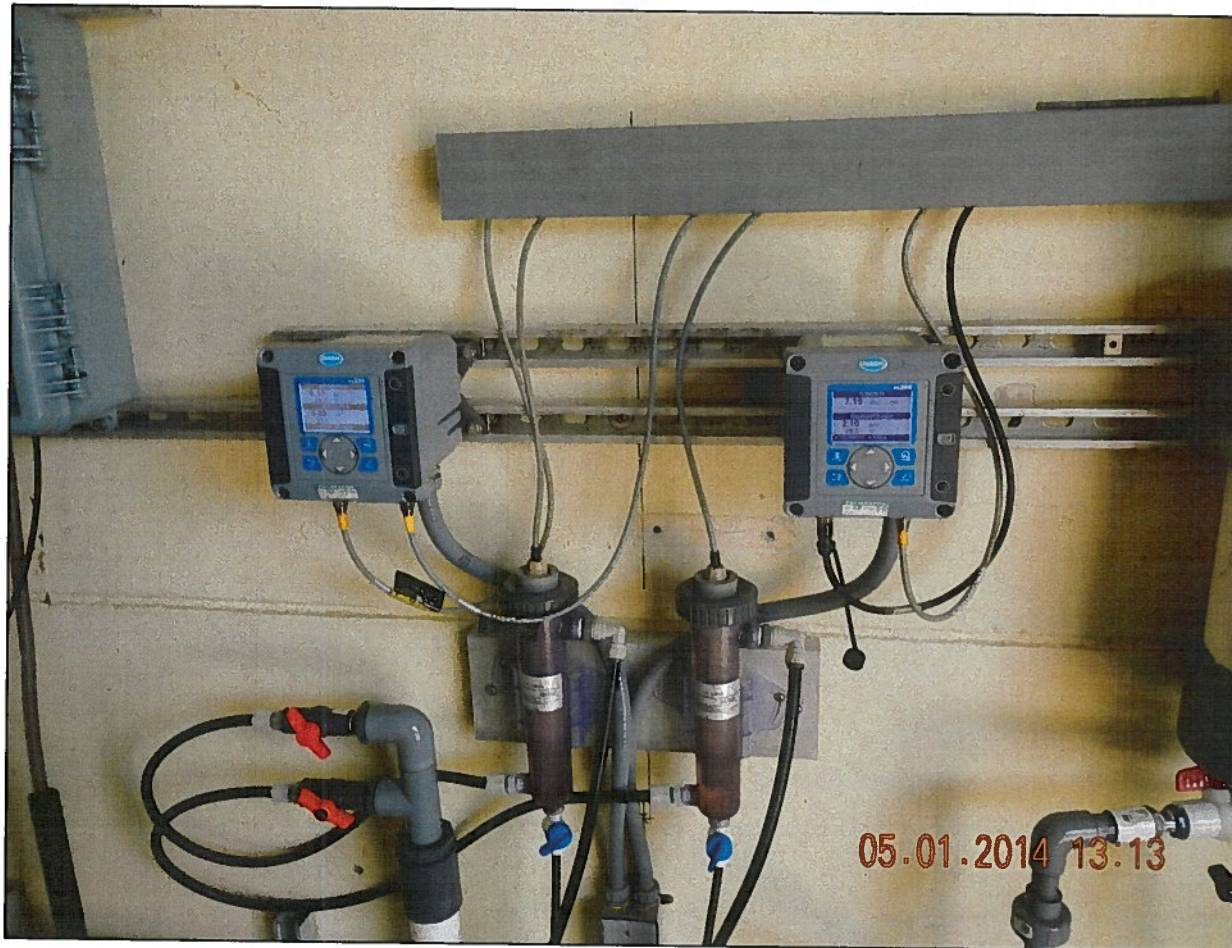
The EPA observed that the effluent automatic sampler had been moved. The interior thermometer temperature was 4° Centigrade. In addition, Miami-Dade has installed effluent pH, Turbidity, Dissolved Oxygen and Residual Chlorine meters, which were all in service at the time of this inspection. *See enclosed photos.*

Miami-Dade Central District WWTP (EPA; 5/1/2014)
pH meter (left); Turbidity/Dissolved Oxygen meter (right) at effluent pump station

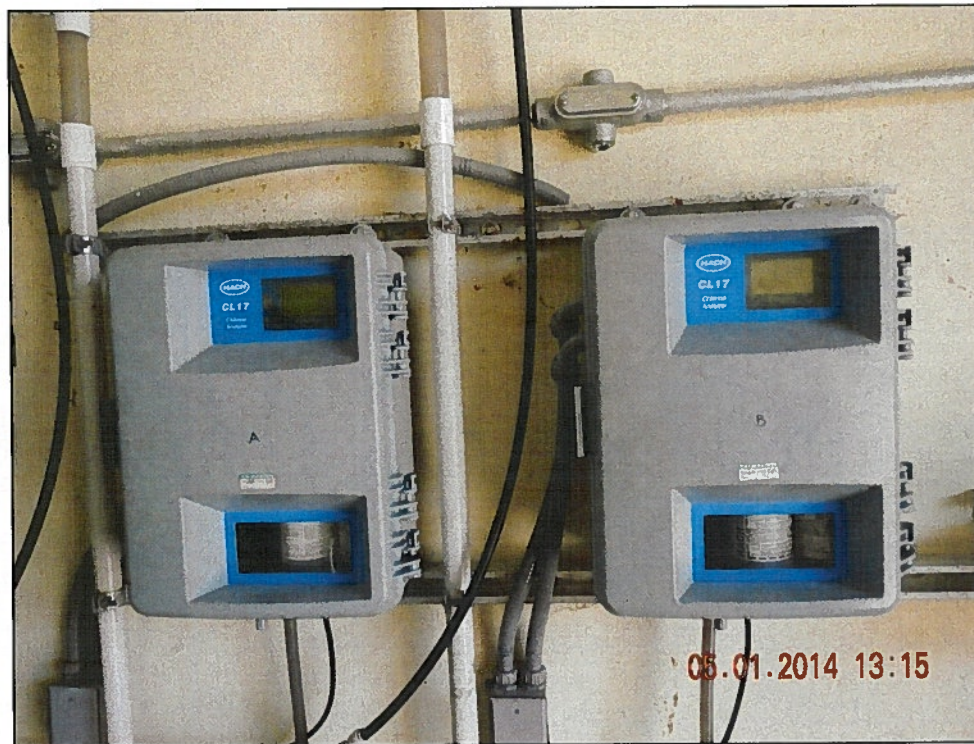
Residual Chlorine meters at effluent pump station

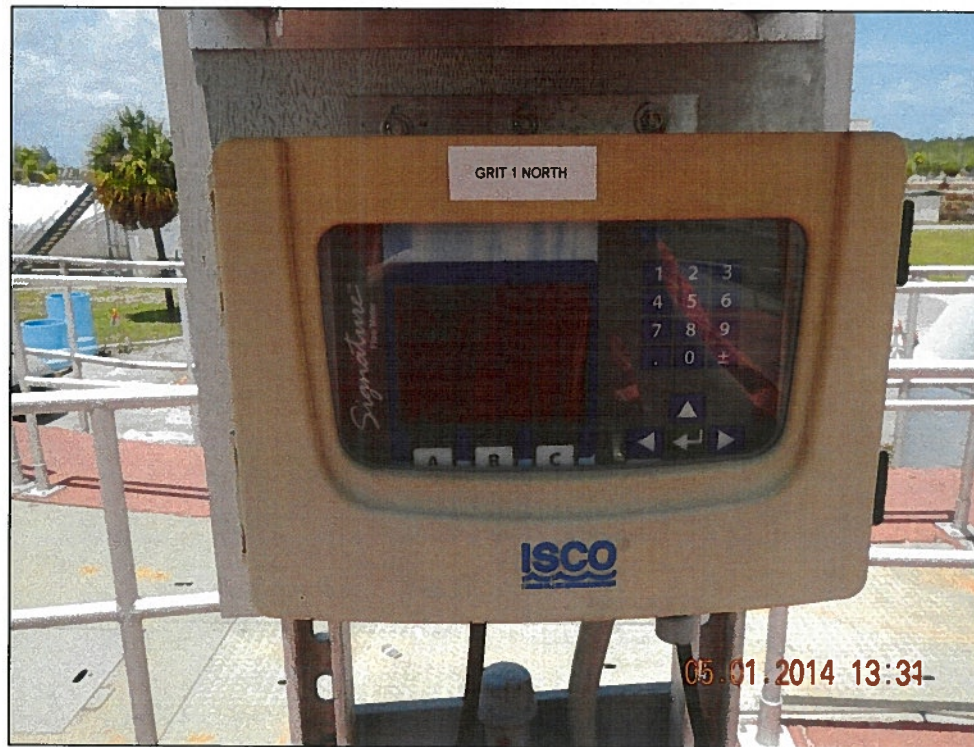
Flow into Plant 1 was observed to be 35.2 MGD (through the north grit chamber) at 1:31 pm. The EPA noted the new influent flow meters at both flumes; see enclosed photo. Mr. Saint-Phard stated that they had completed adjusting weirs that now prevents submersion of the grit chamber flumes. The concrete in the influent chamber was still in bad shape, as it was during the September 2011, April 2012 and April 2013 EPA inspections.

Plant 1, new flow meter (northern grit chamber)

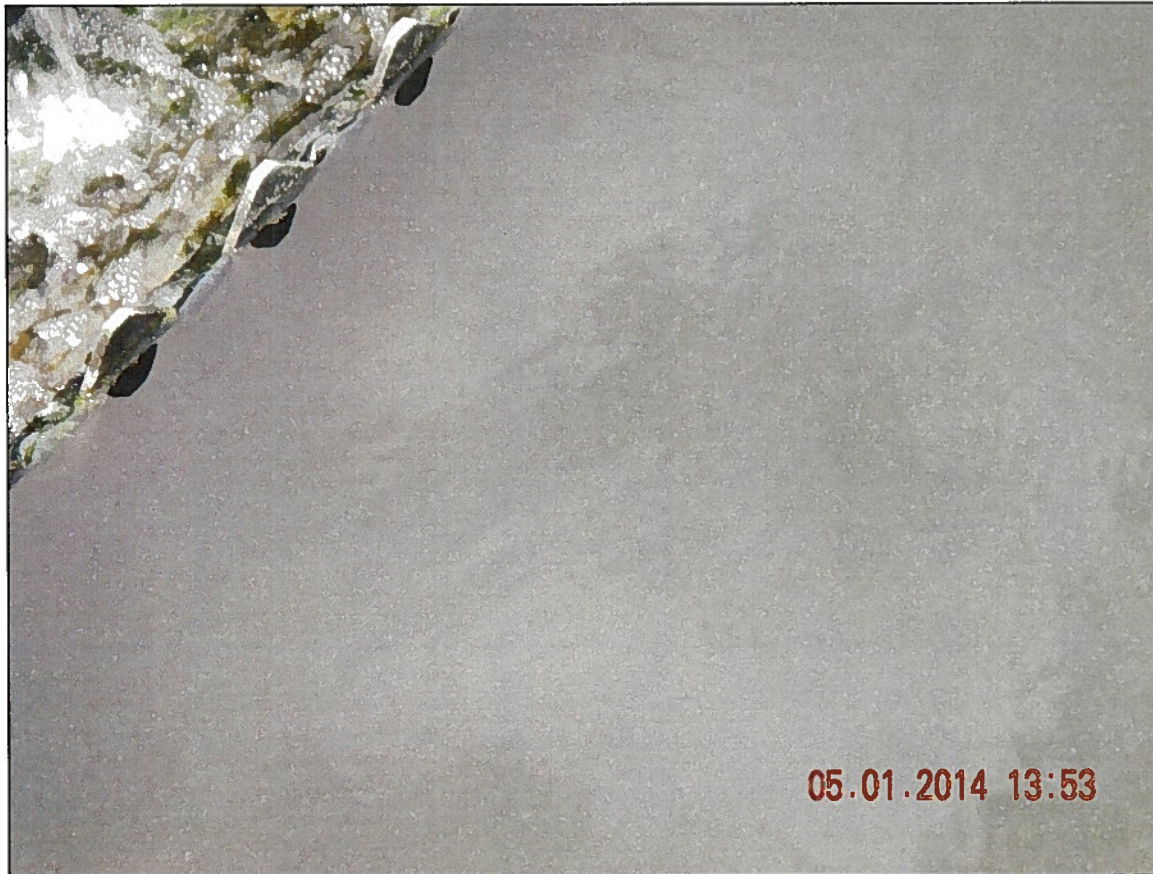
As noted above, final settling tank #1 was offline for routine cleaning and resealing and final settling tank #5 was offline due to a broken skimmer chain. The EPA observed less scum as well as less algae on the weirs in the final settling tanks than during previous inspections. In addition, the EPA observed both algae and very large floatables/debris (e.g., plastic trash, floatable balls) impeding proper weir operation, large amounts of pin floc and large algae mats being discharged. While debris and trash appeared to be less than in previous inspections, the amount of pin floc and large algae mats being discharged out the ocean outfall were greater than seen in the past and are a concern. See enclosed photos.

Plant 1, Final Settling Tank #6C (heavy pin floc discharge)

Violation/Recommendation: Part II, Section B.1. of the EPA-issued NPDES permit requires the permittee to "...at all times properly operate and maintain all facilities and systems of treatment and control (and related appurtenances) which are installed or used by the permittee to achieve compliance with the conditions of this permit." Miami-Dade violated this provision due to final settling tank #5 being offline due to a broken skimmer [NOTE: According to an email from Miami-Dade staff on June 10, 2014, final settling tank #5 was repaired and placed back into service on May 14, 2014 and final settling tank #1 is scheduled to be back in service by July 15, 2014].

In addition, Miami-Dade should explain why the settling tanks are experiencing such large amounts of pin floc that is being discharged (e.g. sludge age and/or blanket depths; not enough sludge wasting due to out of service sludge digesters, etc.). All of the trash, floatables, algae and floc are likely to be discharged through the outfall into the Atlantic Ocean [NOTE: According to an email from Miami-Dade staff on June 10, 2014, the WWTP Operator is now keeping a low sludge blanket to prevent pin floc from being discharged].

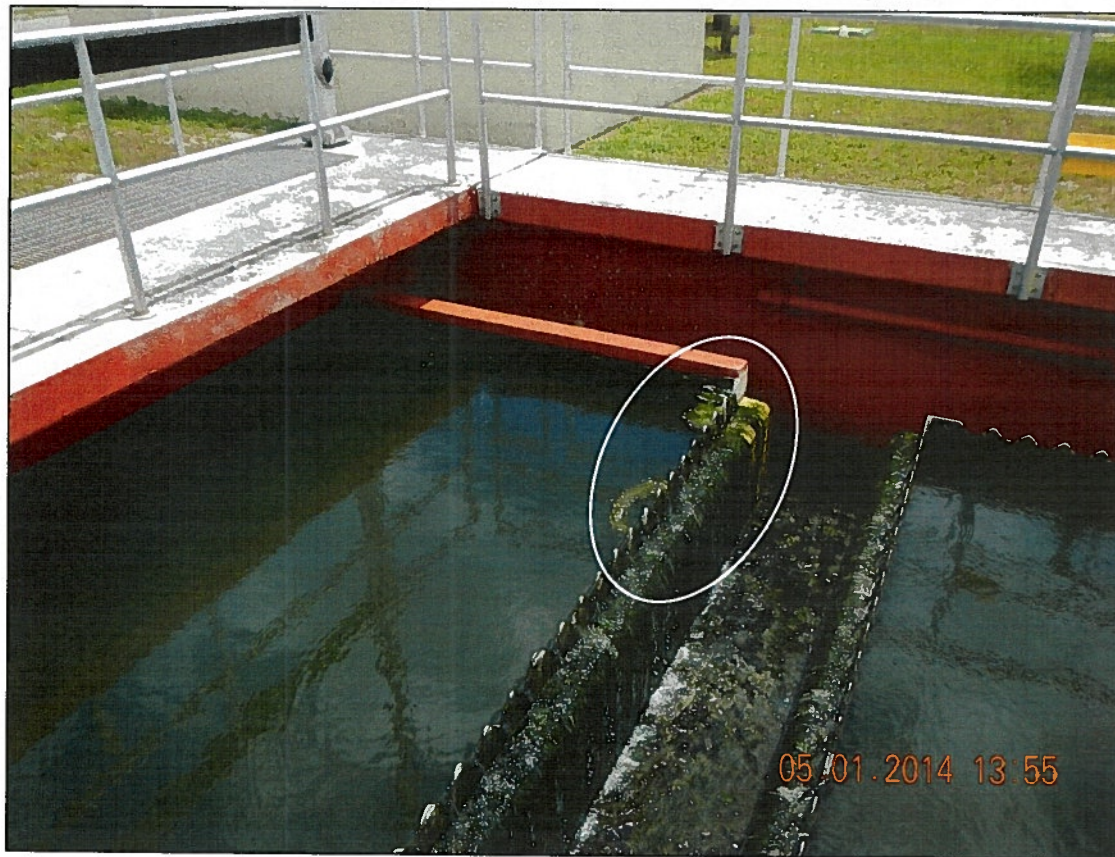
Plant 1, Final Settling Tank #6C (algae on weir blocking flow and into discharge)

Additionally, previous EPA inspections have noted similar trash, floatables, pin floc and algae in the final settling tanks/secondary clarifiers. Miami-Dade WASD appears to be implementing a regularly-scheduled cleaning of the weirs and effluent troughs between tanks, but should consider a Standard Operating Procedure (SOP) to capture larger algae mats as solid waste when cleaning weirs and/or effluent troughs and prevent their passage into the effluent channel [NOTE: According to an email from Miami-Dade staff on June 10, 2014, WWTP staff now catch larger debris/algae with pool nets when washing down weirs].

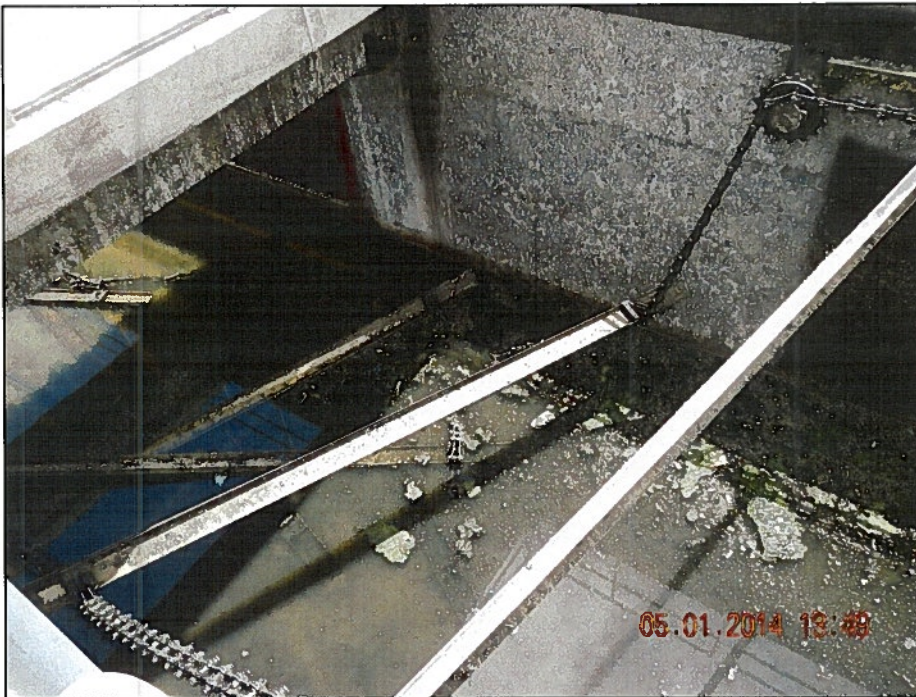
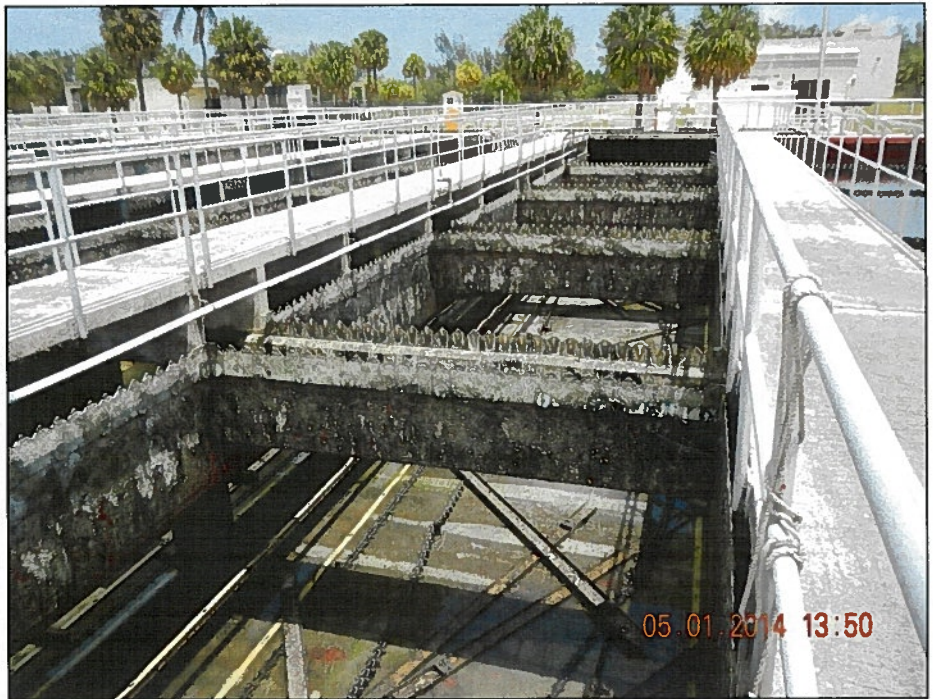
Plant 1, Final Settling Tank #5 (broken chain + collapsed scum/solids flights)

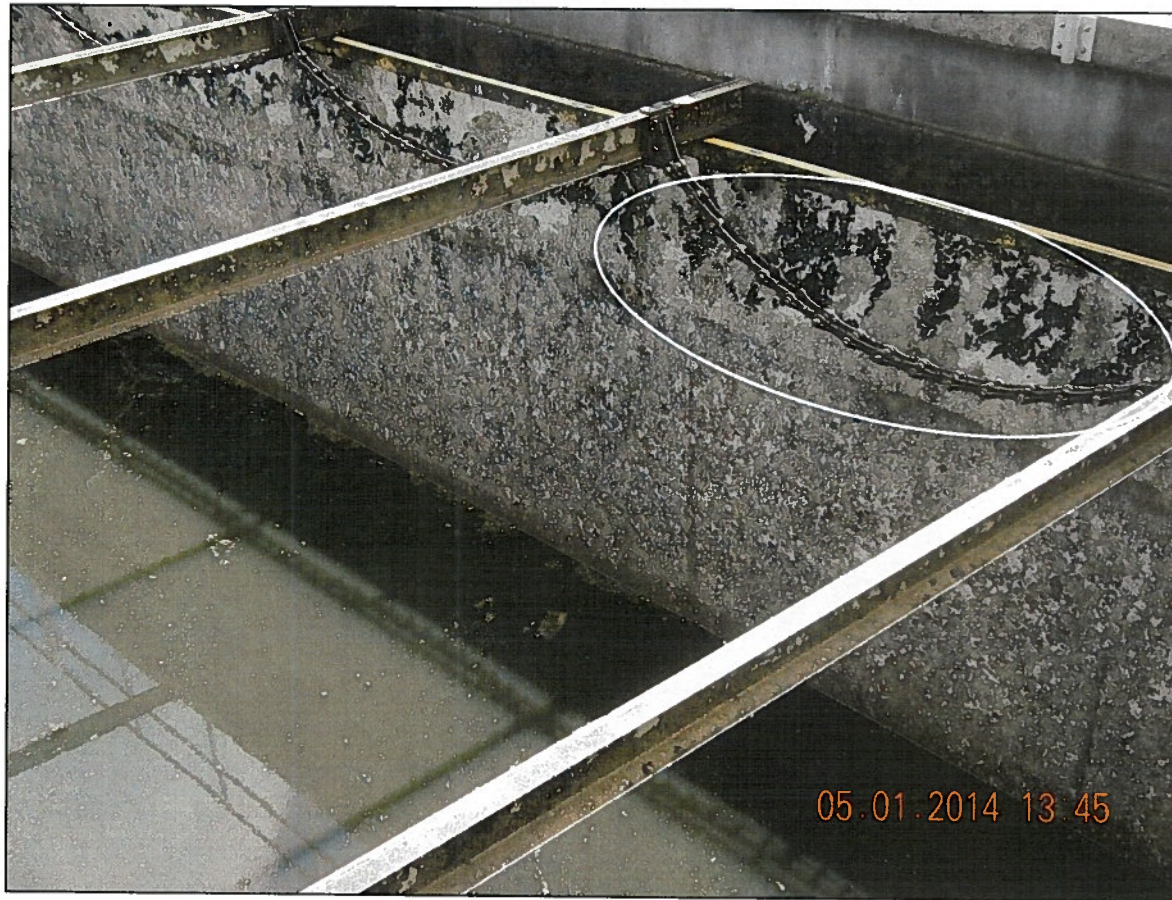
Plant 1, Final Settling Tank #5C (black sealant on wall eroded)

Deficiency/Recommendation: Structural/concrete issues were noted in several areas of Plant 1. Structural/concrete issues pose safety hazards for WWTP staff. Miami-Dade should address all of the structural/infrastructure issues within Plant 1 pursuant to the deadlines in the new Consent Decree.

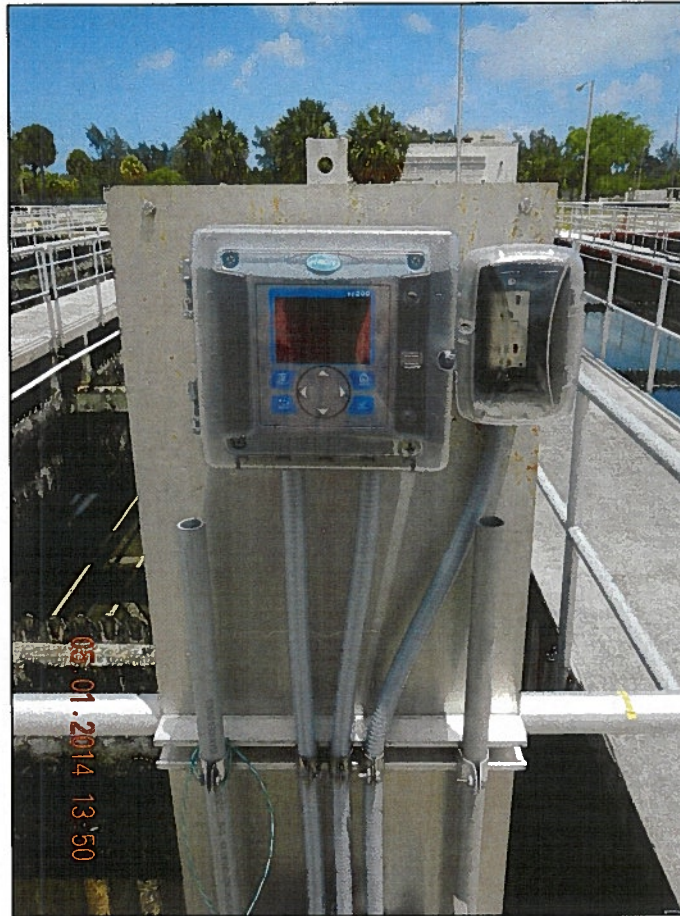
Mr. Saint-Phard showed the EPA the ultrasonic sludge blanket depth monitor in final settling tank #5C that was installed after the demonstration project in final settling tank #6 noted in EPA's April 2013 inspection. Mr. Saint-Phard noted that he was still waiting on the electrician to complete installation of the new monitor. *See enclosed photo.*

Plant 1, Sludge blanket meter at Final Settling Tank #5C awaiting electrical connection

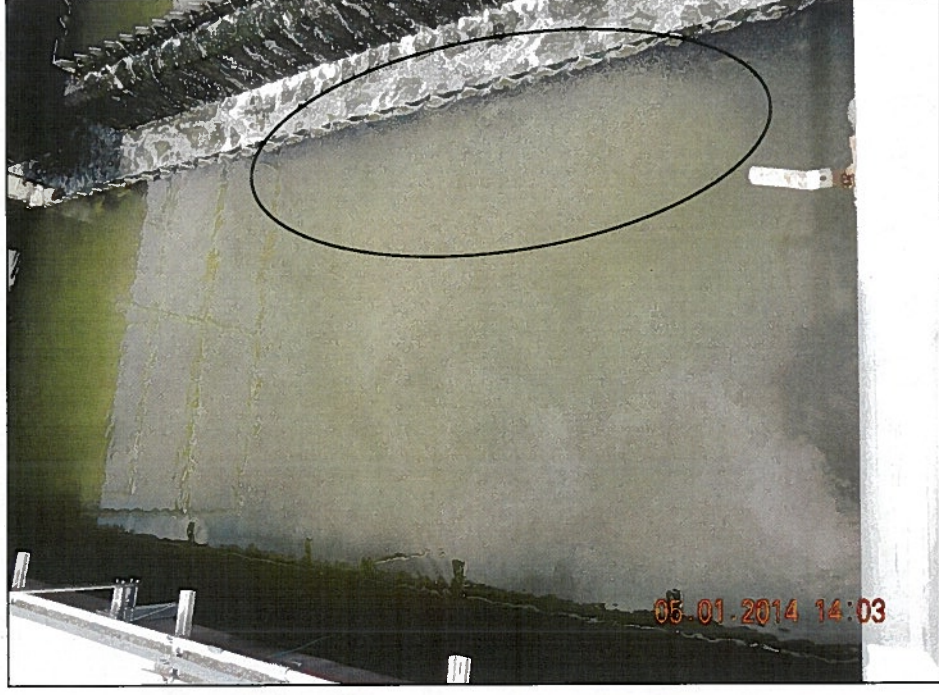
Plant 1, Final Settling Tank #3B (heavy pin floc)

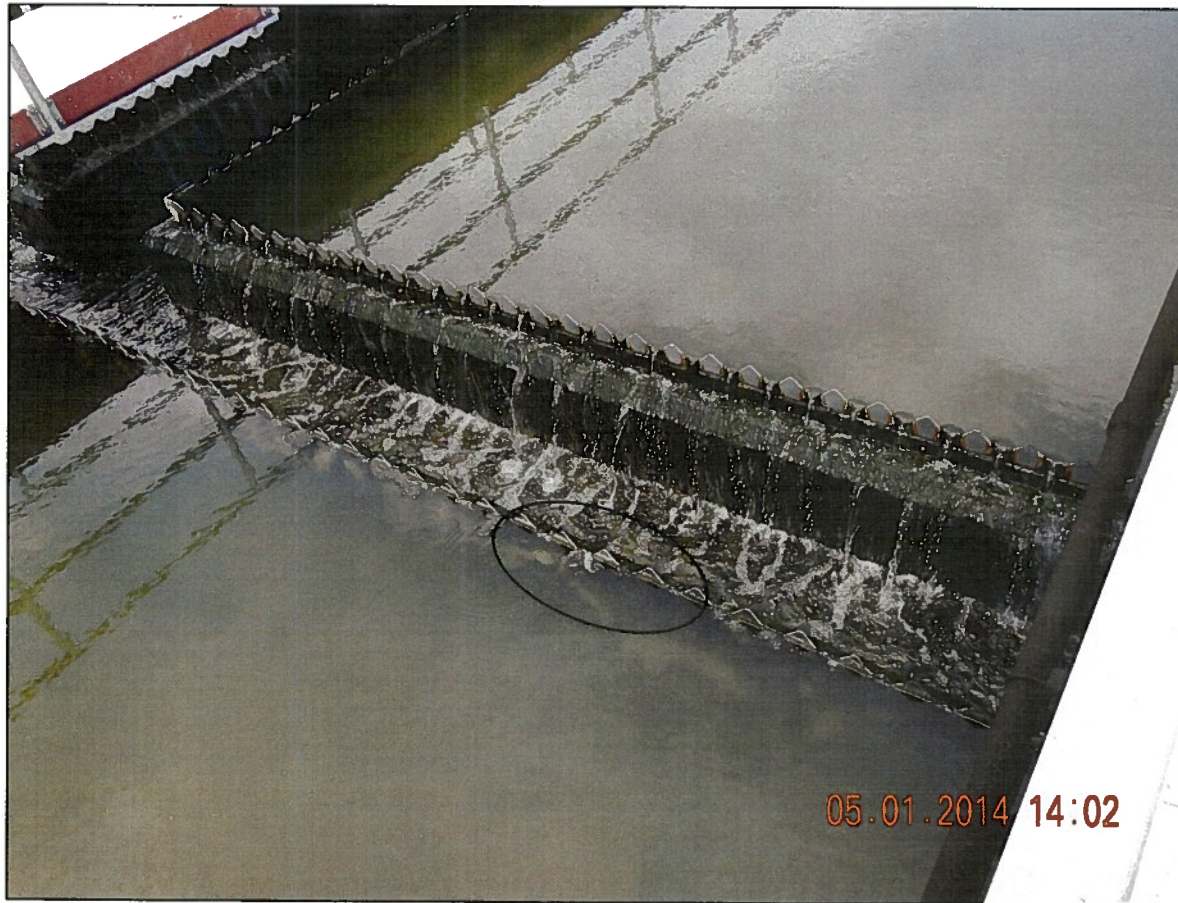
Plant 1, Final Settling Tank #3B west (debris on weir + heavy pin floc)

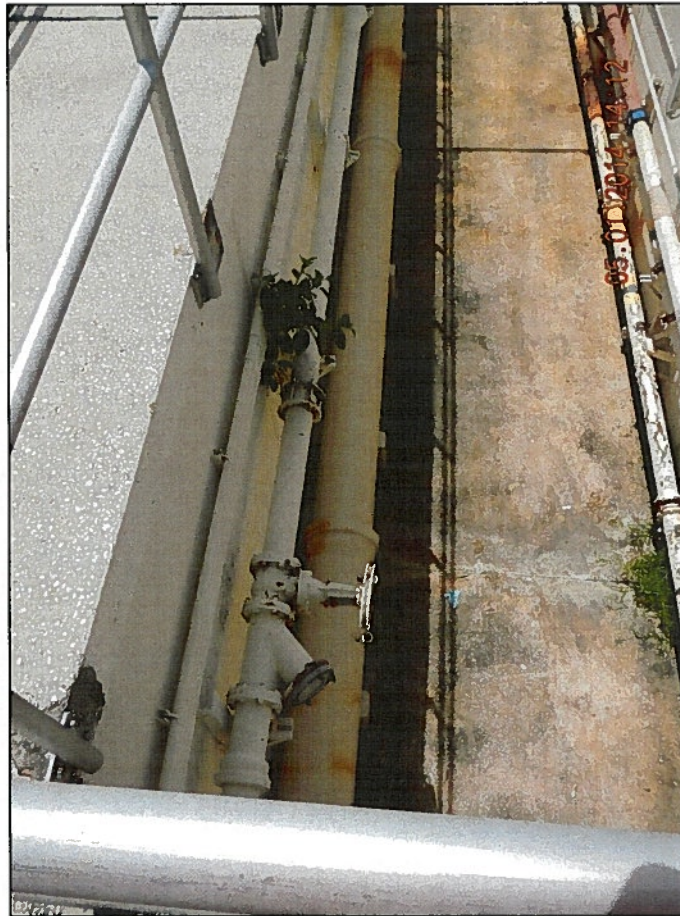
Plant 1, Final Settling Tank #3C skimmer wall (foliage growing through crack in wall)

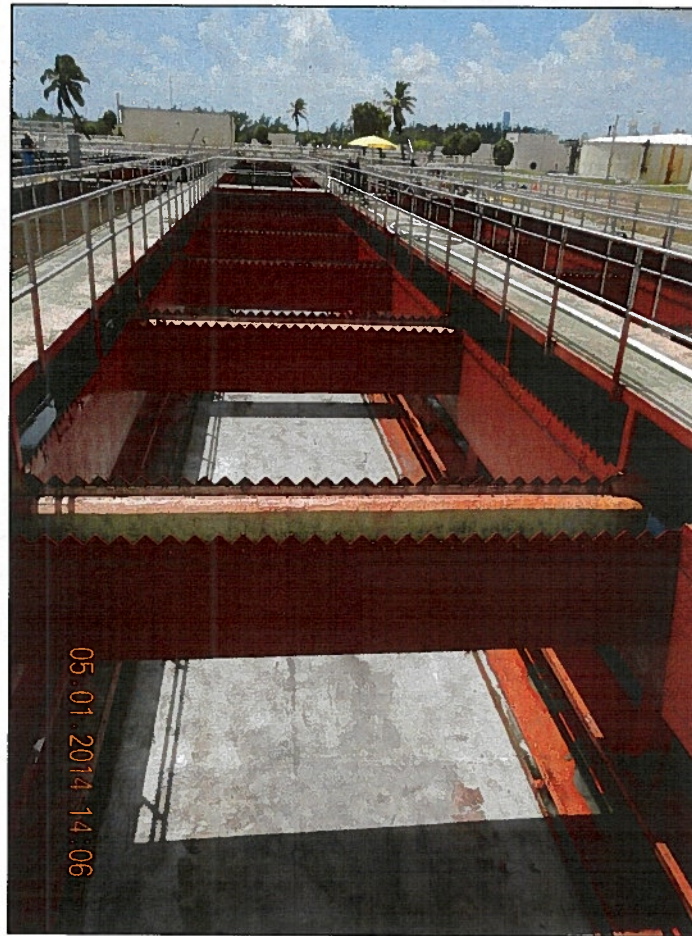
Plant 1, Final Settling Tank #1B (recently cleaned and recoated)

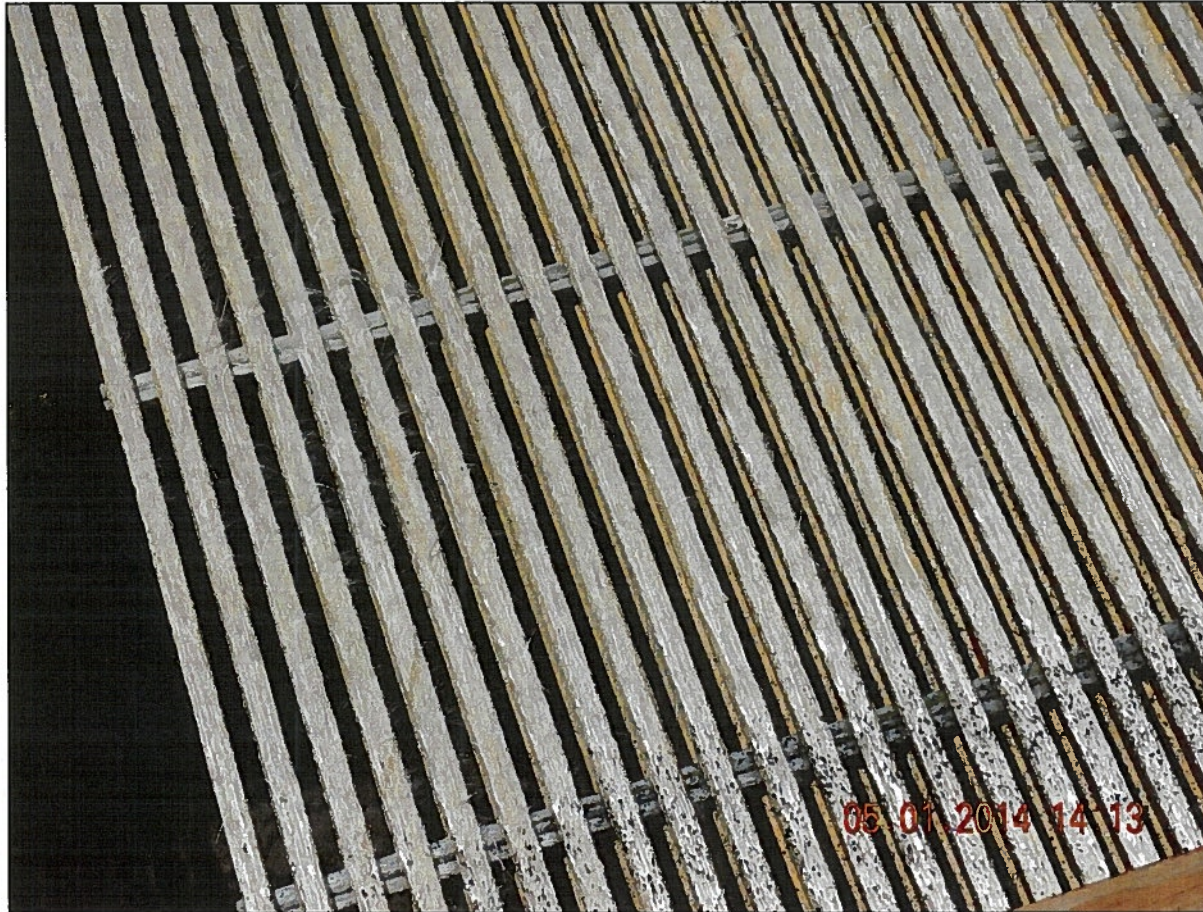
The EPA noted that the fiberglass grating over the scum trough of the final settling tanks was worn and Mr. Saint-Phard stated that these grates are to be replaced by aluminum grating soon; *see enclosed photo* [NOTE: According to an email from Miami-Dade staff on June 10, 2014, these grates were replaced by the end of May 2014]. In addition, the EPA noted several locations in the walkways between the final settling tanks that had structural cracks in the concrete all the way through the walkway.

Plant 1, Final Settling Tank #1 scum trough fiberglass grate

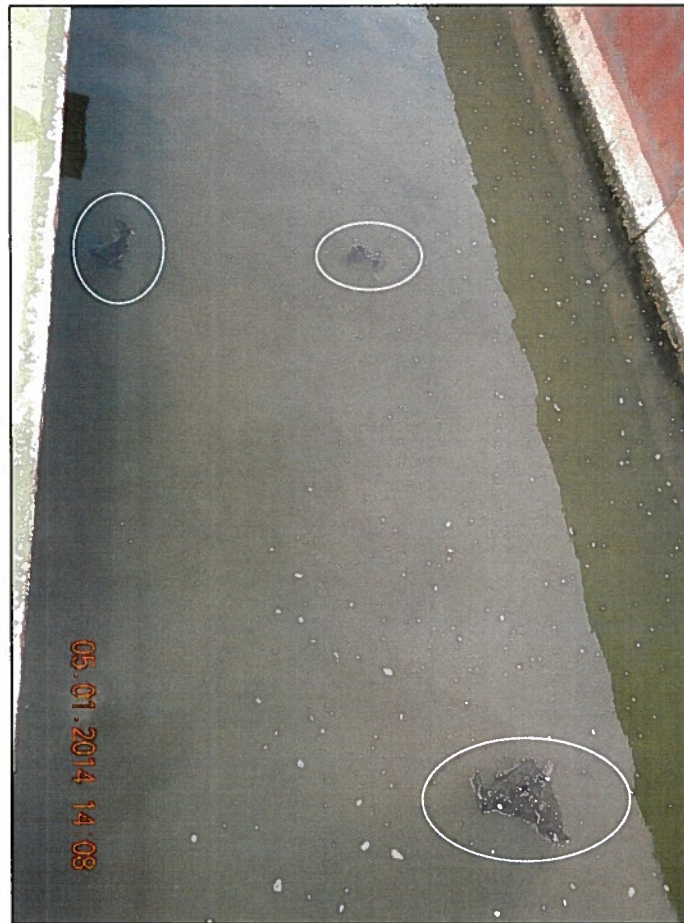
Plant 1, Final Settling Tank effluent near #1A (large algae bricks in discharge)

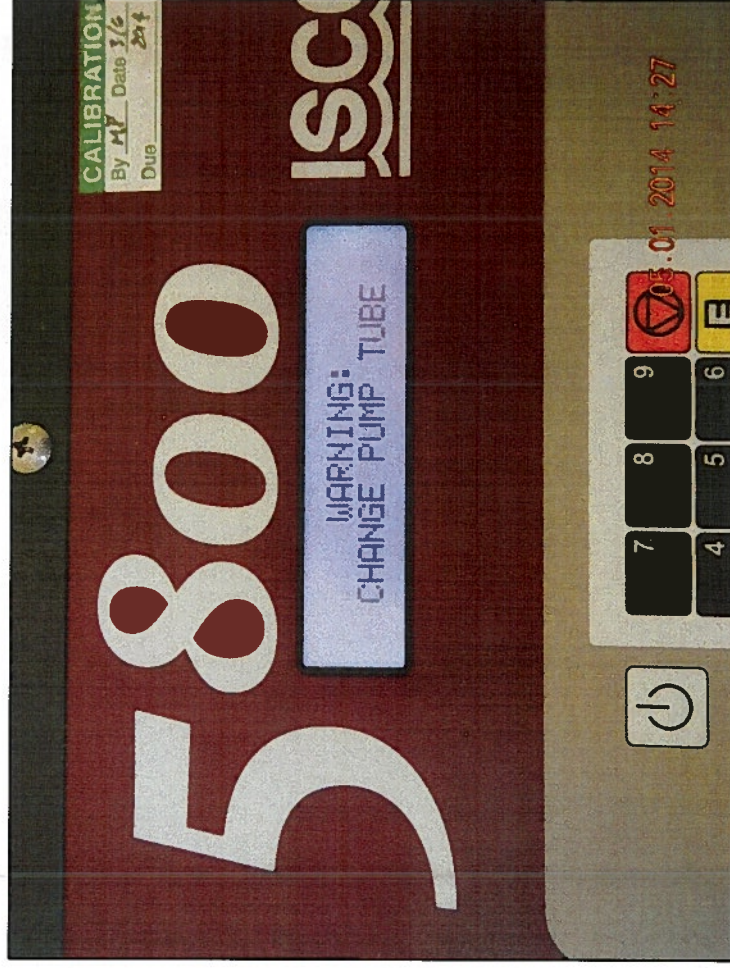
No concrete/structural improvements were noted in the influent grit building. There were 2 influent automatic samplers present during this inspection in the grit building. Mr. Saint-Phard stated that the sampler being used for reporting on the DMR (ISCO 5800) was the one in the rear, which had been calibrated on 3/16/2014. The sampler readout indicated that the sample tubing needed to be replaced. The intake tubing was observed to be consumed with solids, and the pump outtake tubing contained algae. The sampler readout indicated the refrigerator was 1.4° Centigrade and it had been recorded as 2.0° Centigrade earlier that day on the temperature log. The interior manual thermometer was not checked. *See enclosed photos.*

Plant 2, influent automatic sampler (error display + dirty tubing)

Violation/Recommendation: Part II, Section C.1. of the EPA-issued NPDES permit requires Miami-Dade to take representative samples. The dirty pump tubing on the Plant #2 influent automatic sampler adds pollutants to the influent sample, resulting in a non-representative sample that can impact percent removal results. Miami-Dade should replace the influent sampler tubing as soon as possible [NOTE: According to an email from Miami-Dade staff on June 10, 2014, this automatic sampler tubing was replaced prior to the email and is inspected weekly].

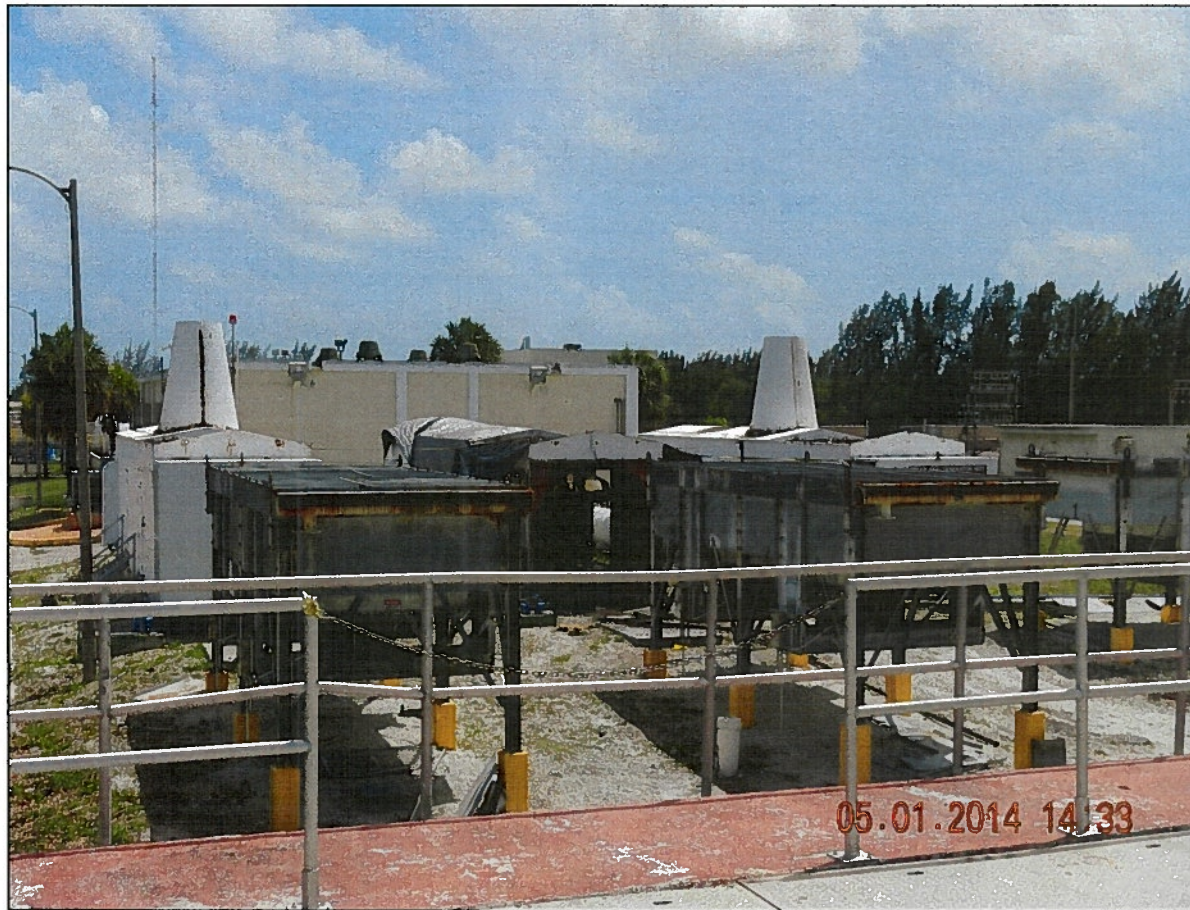
WWTP generators (background) + external radiators (foreground)

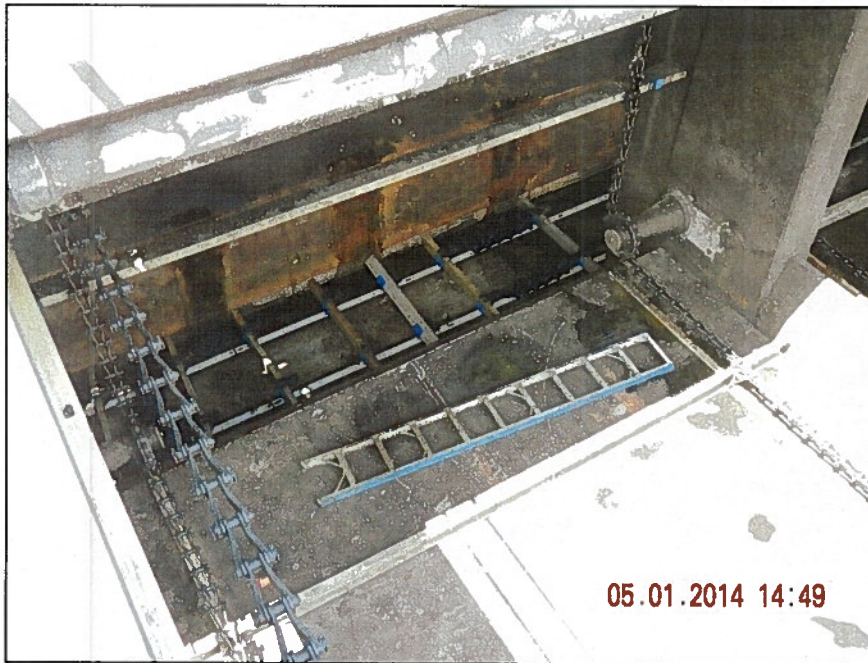
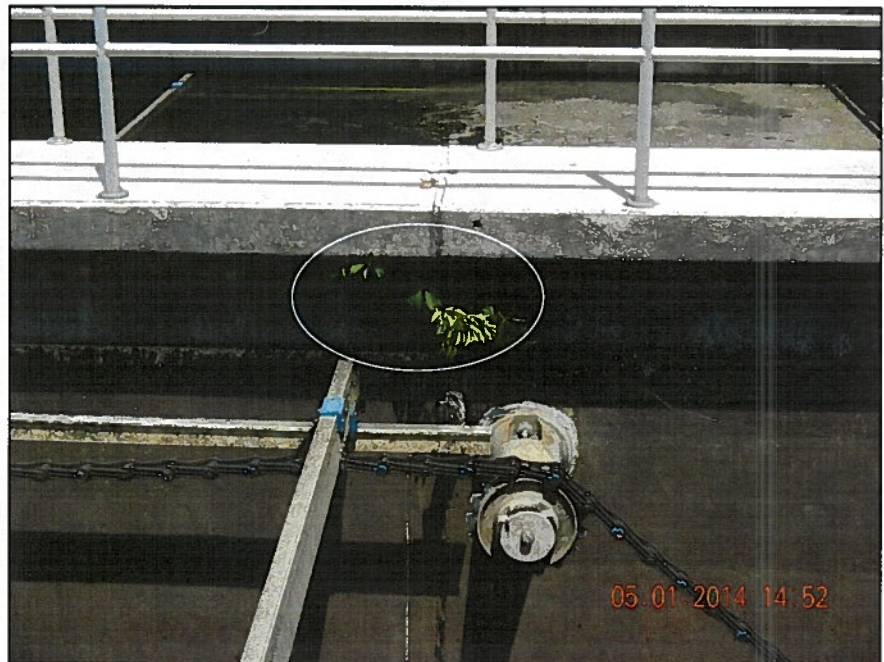
Final settling tank #4 was out of service for routine cleaning. Mr. Saint-Phard explained that the cross-collector which draws solids from the passes, had not been used in the past. When this final settling tank was taken offline for routine maintenance, it was noted that the debris in the cross collection trough prevented the cross-collection arms from being used. The cross-collection trough had been cleaned out prior to this inspection and Mr. Saint-Phard reiterated that this tank would be placed back into service the following day [NOTE: According to an email from Miami-Dade staff on June 10, 2014, this final settling tank (#4) was placed back in service prior to the email]. Final settling tank #6 was observed to have been resealed prior to this inspection.

Plant 2, Final Settling Tank #4 (cross collector under repair(L) and foliage in wall (R))

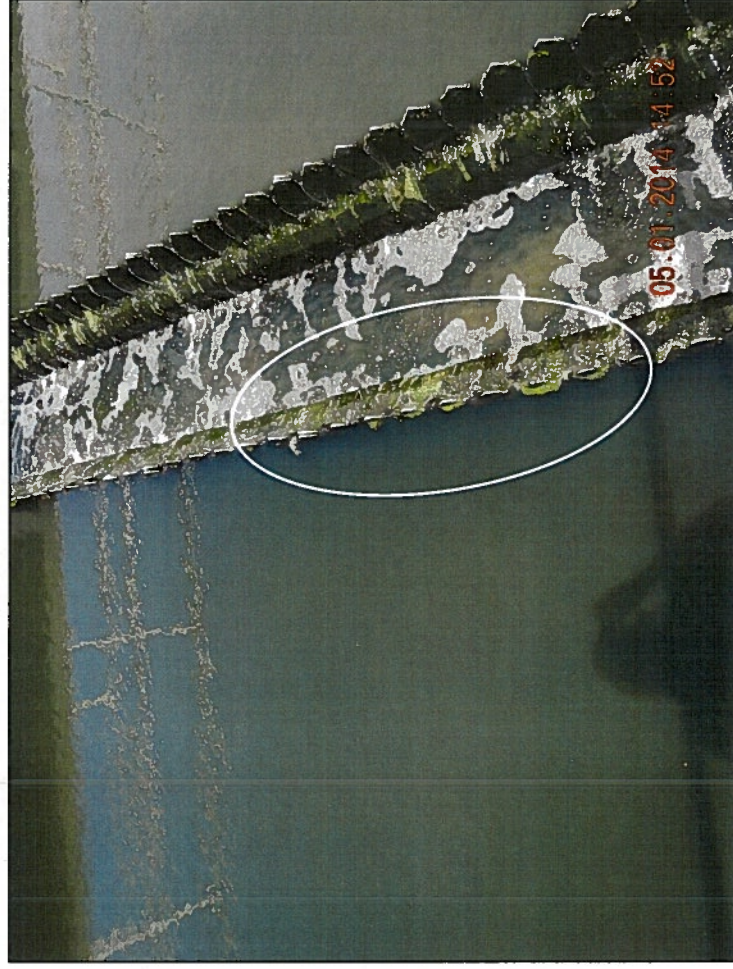
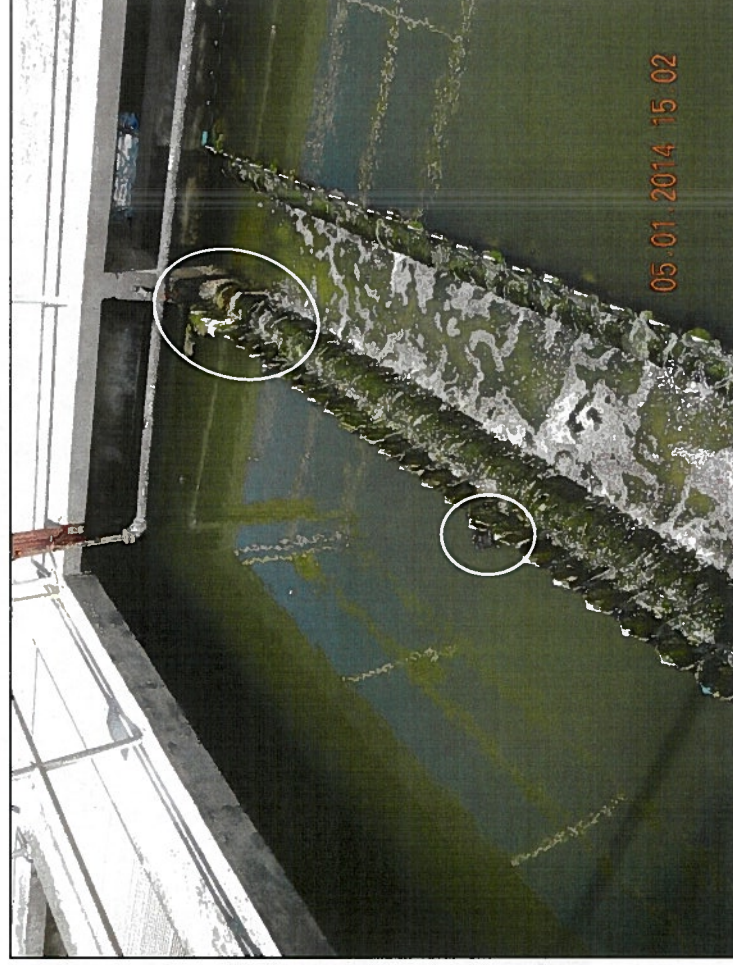
In the final settling tanks/secondary clarifiers, the EPA observed some algae and large floatables, trash/debris (e.g., plastic trash), unsettled floc and large amounts of pin floc. In addition, the EPA observed some large algae bricks being discharged out of the effluent trough of the final settling tanks. *See the enclosed photos.*

Plant 2, Final Settling Tanks #5B (L) and #8C (R) (debris at weirs)

Violation/Recommendation: Part II, Section B.1. of the EPA-issued NPDES permit requires the permittee to "...at all times properly operate and maintain all facilities and systems of treatment and control (and related appurtenances) which are installed or used by the permittee to achieve compliance with the conditions of this permit." Previous EPA inspections have noted similar trash, floatables, algae and pin floc in the final settling tanks/secondary clarifiers. While less of these items were noted than in previous inspections and Miami-Dade WASD appears to be implementing a regularly-scheduled cleaning of the weirs and effluent troughs between tanks, Miami-Dade should consider a SOP to capture larger algae mats as solid waste when cleaning weirs and/or effluent troughs and prevent their passage into the effluent channel [NOTE: According to an email from Miami-Dade staff on June 10, 2014, WWTP staff now catch larger debris/algae with pool nets when washing down weirs].

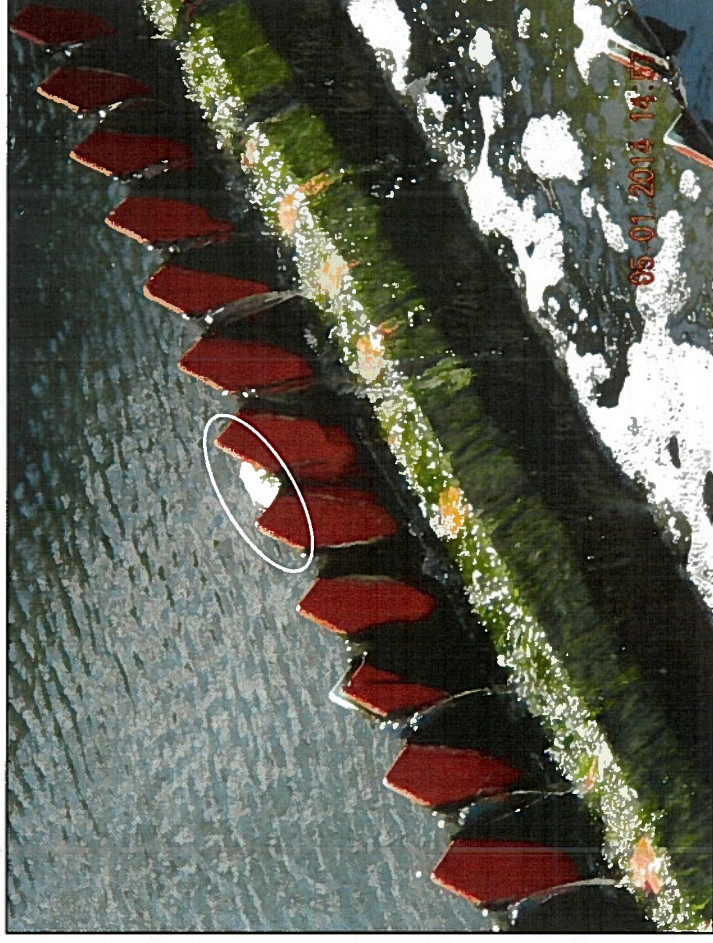
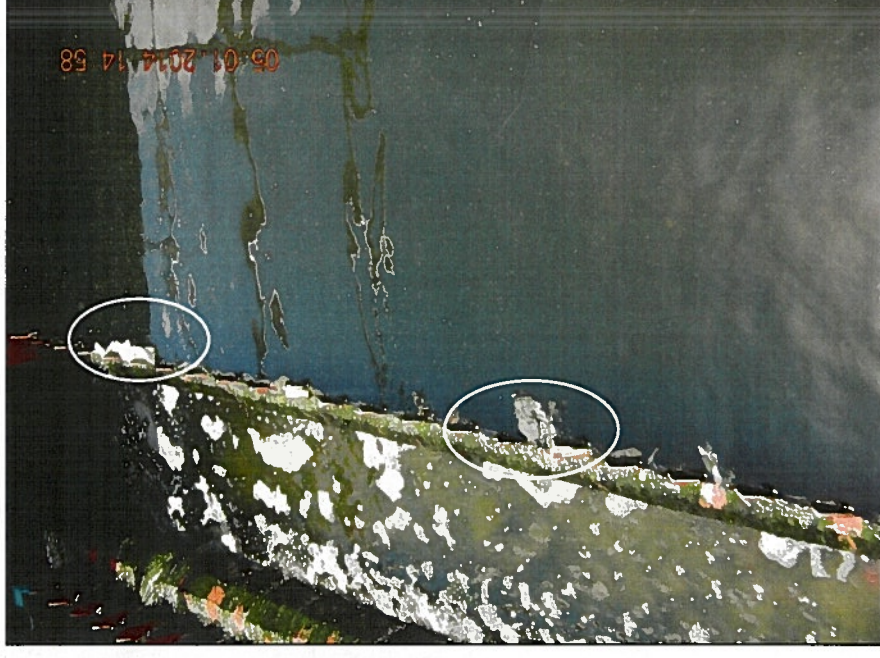
Plant 2, Final Settling Tank #6A (debris blocking weirs)

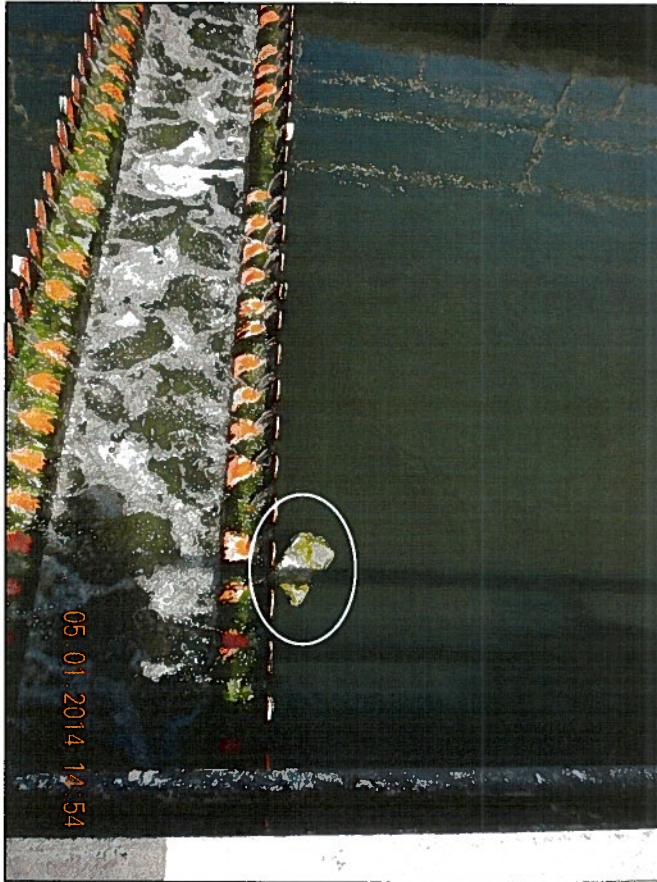
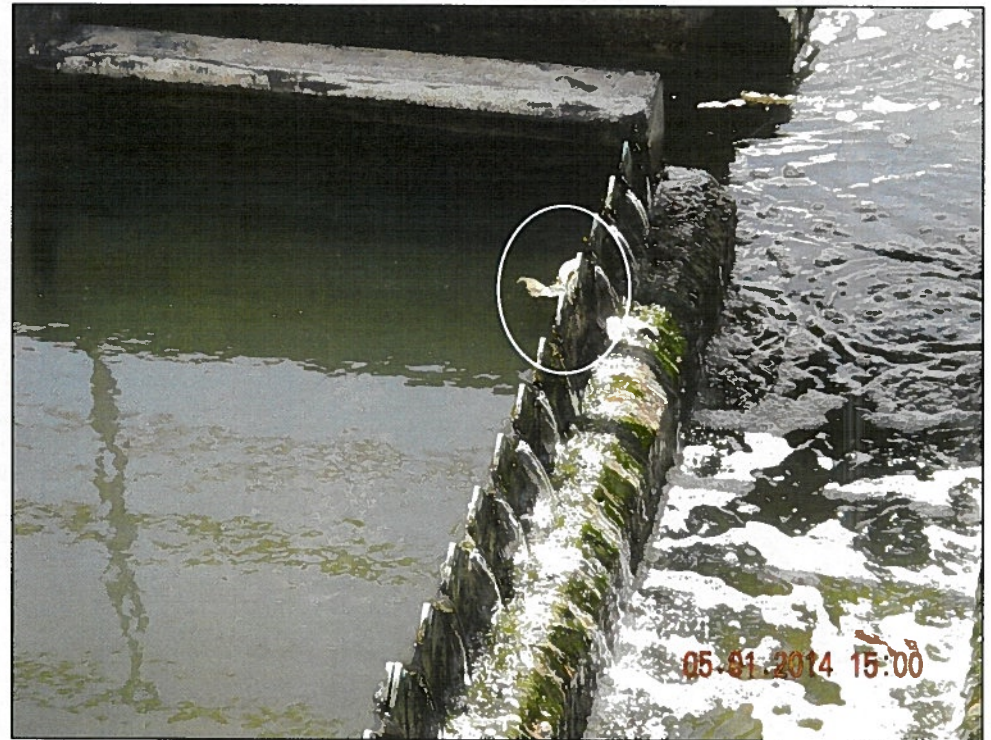
Plant 2, Final Settling Tanks #6A (L) and #7C (R) (Chip bag + debris at weirs)

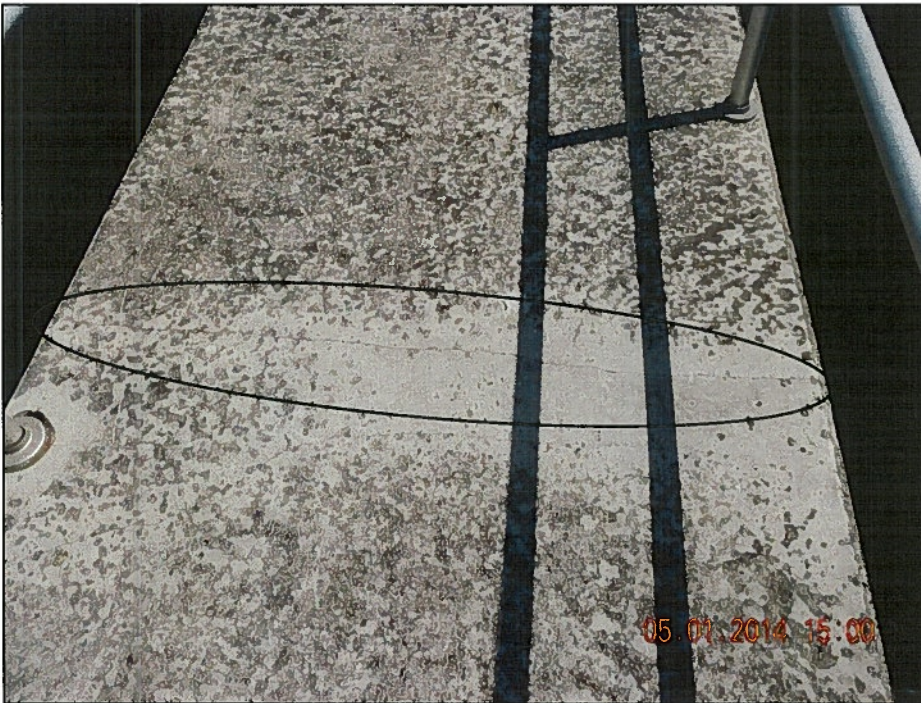
The EPA noted several locations in the walkways between the final settling tanks that had structural cracks in the concrete all the way through the walkway.

Plant 2, Final Settling Tank #6C/7A walkway (note crack through walkway)

Deficiency/Recommendation: The structural cracks in the walkways may present a safety hazard to workers and compliance inspectors should the walkways fail while in use. Miami-Dade should thoroughly inspect and address walkways with structural risks and implement all structural repairs pursuant to the deadlines in the new Consent Decree.
